## Marine Notice No. 9 of 2017

EPIRB Information Bulletin:  
McMurdo Smartfind EPIRB – (all versions)  
Kannad Marine EPIRB – Sport/Sport Pro/Sport Pro +

# Information BULLETIN

## Top dome replacement

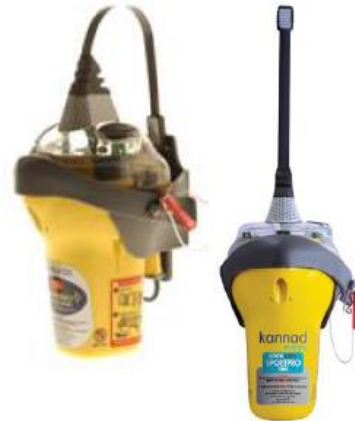
It has come to our attention that the top dome under certain circumstances may begin to show signs of localised craze cracking. Small cracks may appear to be radiating out from the three over moulded screw inserts.

1. Clearly, any cracking is undesirable and unsightly and our recommendation is that the EPIRB should be subject to rectification work at earliest opportunity.
2. Should you have any concern with regarding the condition of your EPIRB you are invited in the first instance to contact the McMurdo customer support team for advice.
3. If the EPIRB is in warranty period, complete an RMA application using the online form:-

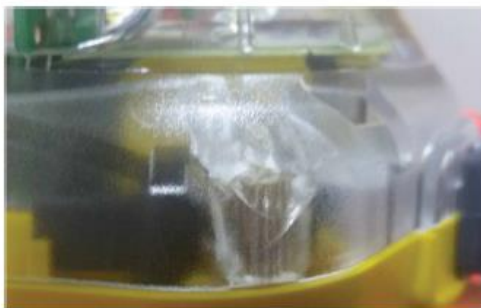
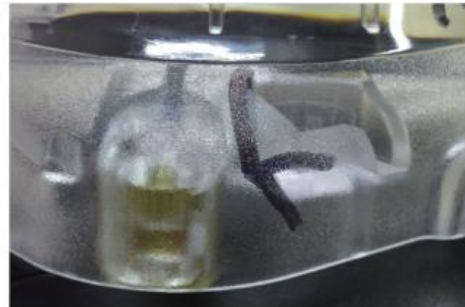
The cracking area is outside of the waterproof seal (main O ring seal) in a wet zone which is a self-draining cavity. As such, any cracking in this area will not compromise the waterproof body seal in anyway, or significantly weaken the overall integrity of the EPIRB.
