Prepared for
The Moore Street Consultative Group
by
Paul Arnold Architects
November 2016

MOORE STREET SELECTED EXTERNAL PHOTOGRAPHS

MOORE STREET SELECTED INTERNAL PHOTOGRAPHS

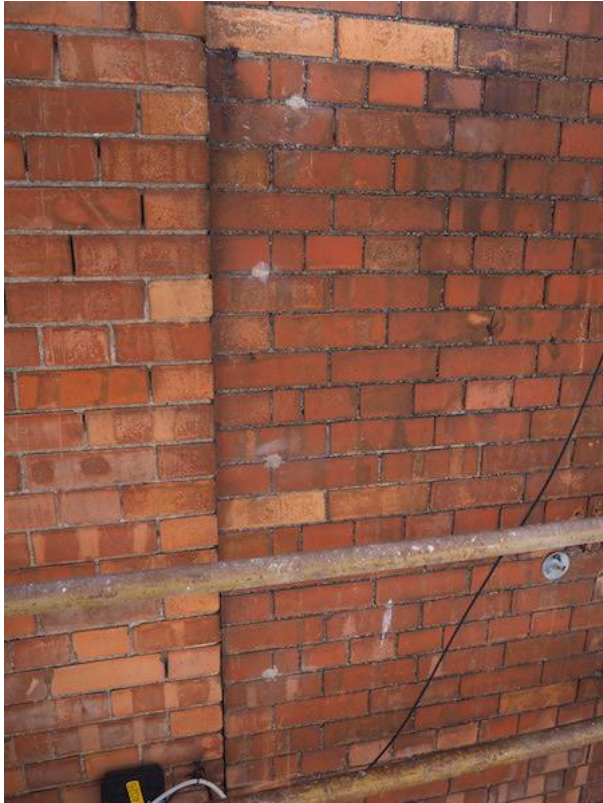
P3.1 The repaired holes are visible every fourth or fifth course

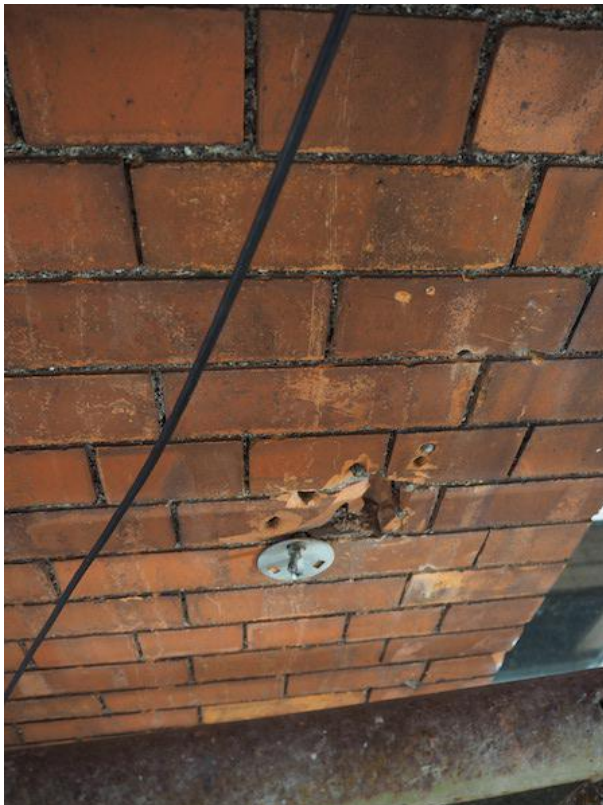
P3.3 Generations of signs and other objects have been fixed to the facades over time, leaving damage in their wake

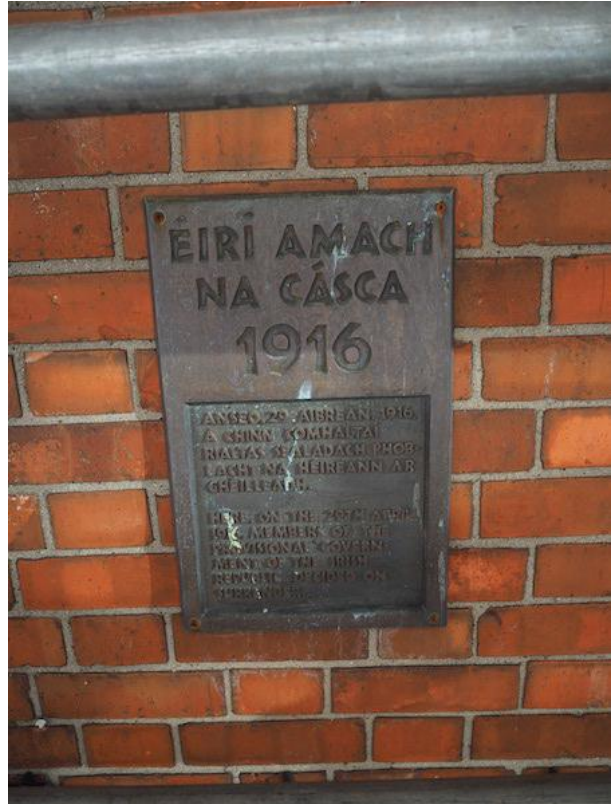
P4.2 This plaque is to be retained in position

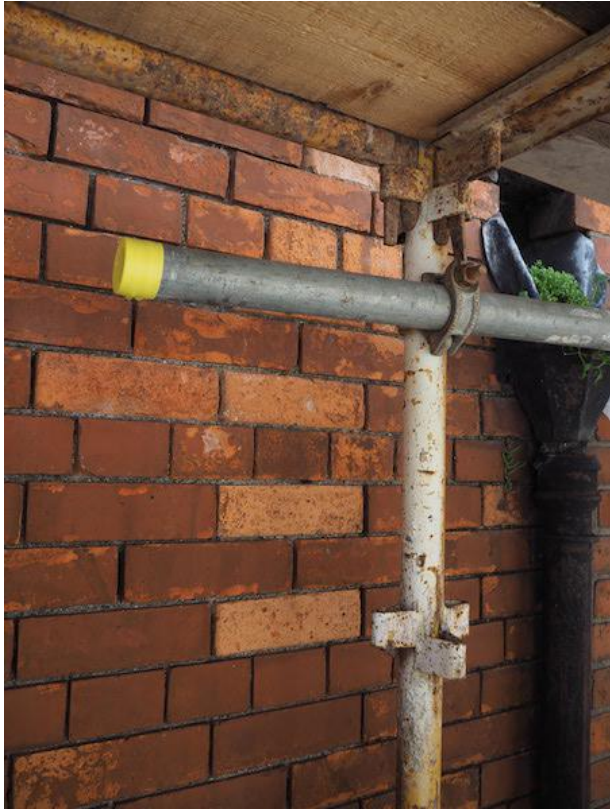
P6.1 Many bricks have lost their protective 'fire-skin', leaving them prone to more rapid decay

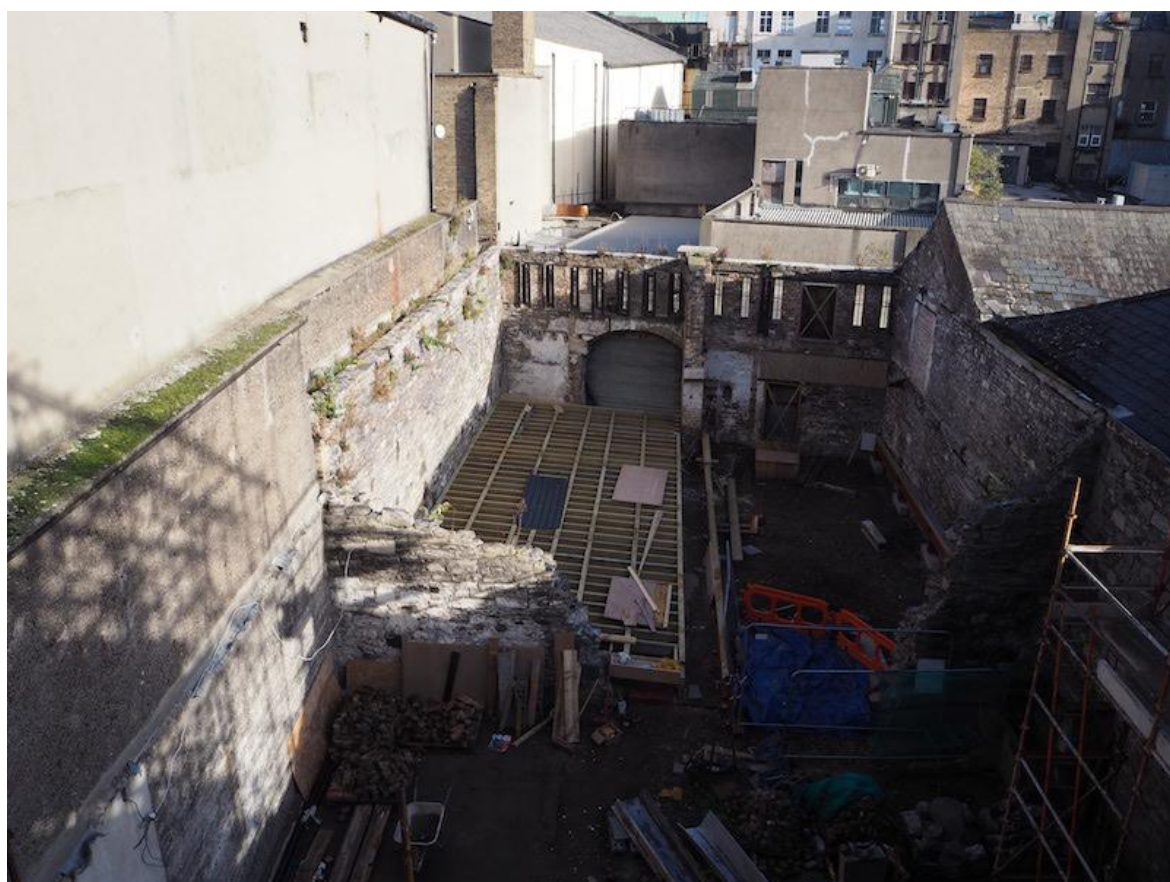
P12.2 The temporary roof which is designed to reduce water ingress to the subterranean cellars is being installed: the thin concrete shells which form the roof of the cellars will thus be protected from traffic, albeit inhibiting site access from Moore Lane in the short term

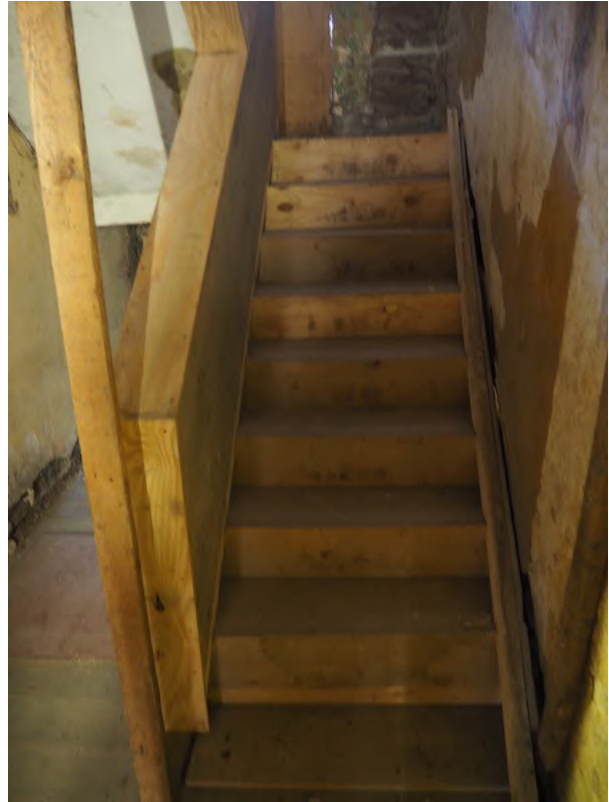
P16.2 Protection in place on a staircase

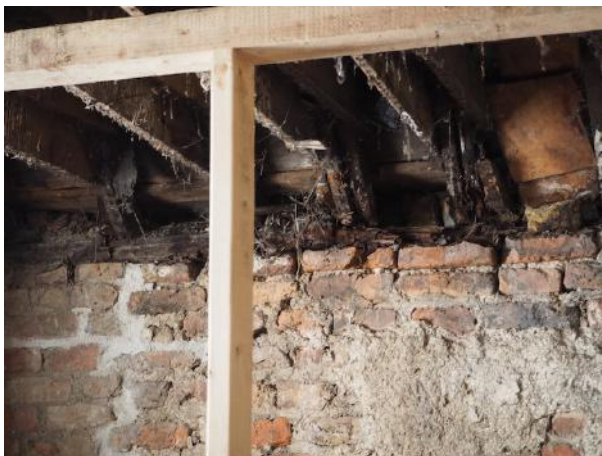
P16.5 Timber decay at roof level

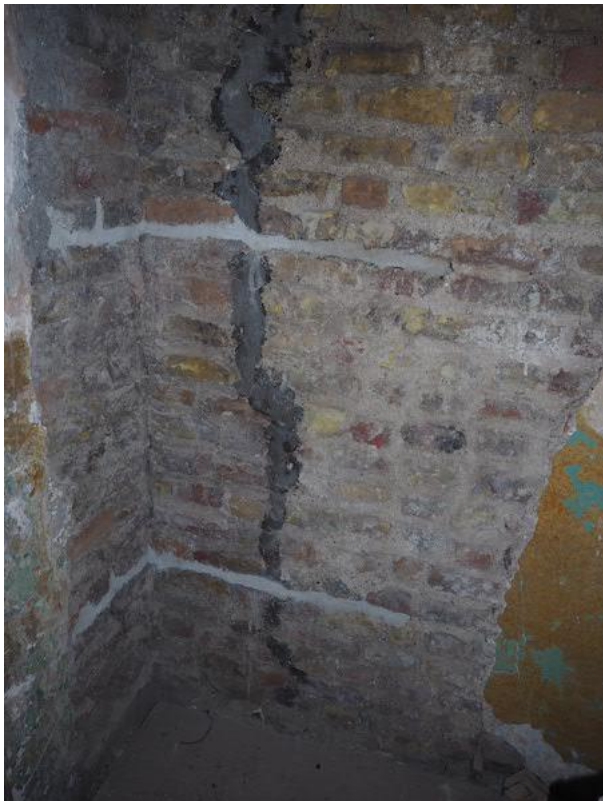
P17.5 Stainless steel helibars inserted to tie the facades to flanking walls

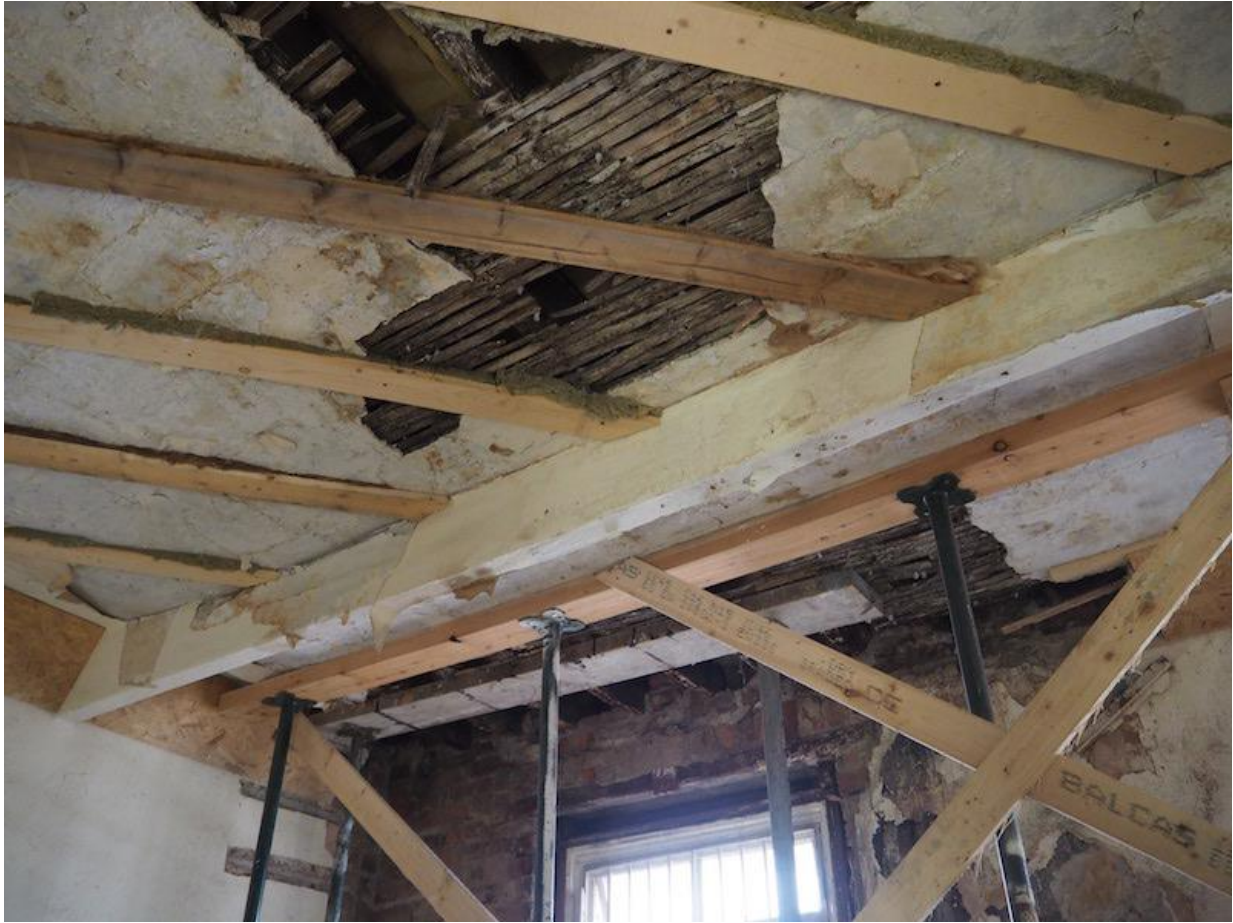
P29.1 The diagonal planks on the ceiling are an older attempt to retain the decayed plaster ceiling in position: it is probably beyond repair.

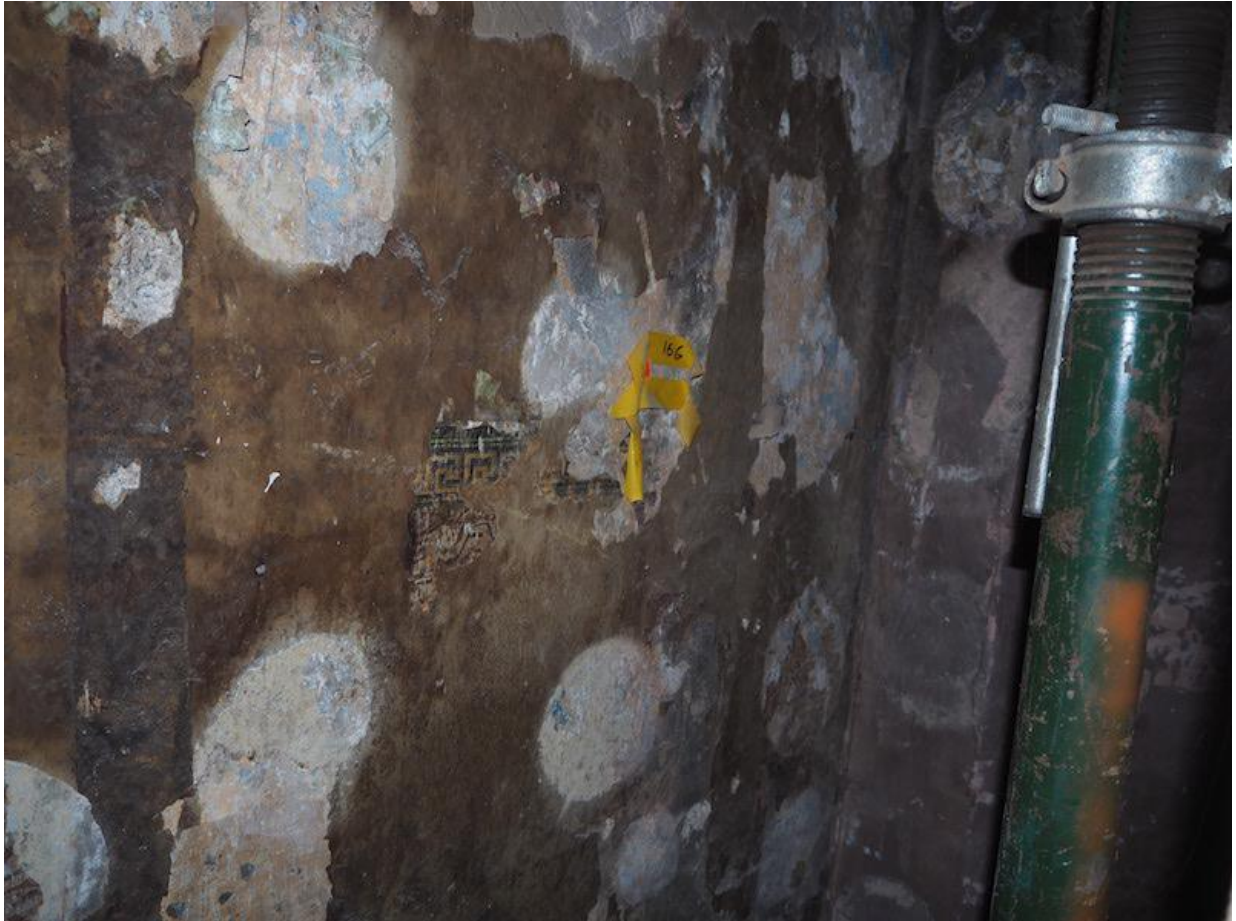
P35.1 The fragments of wallpaper in No 17 which are of historic interest.
