**Submission to the Minister of Public Expenditure and
Reform concerning the Proposed River Bride (Blackpool)
Drainage Scheme**

Tadhg O'Leary & Jer Buckley

26 February 2020

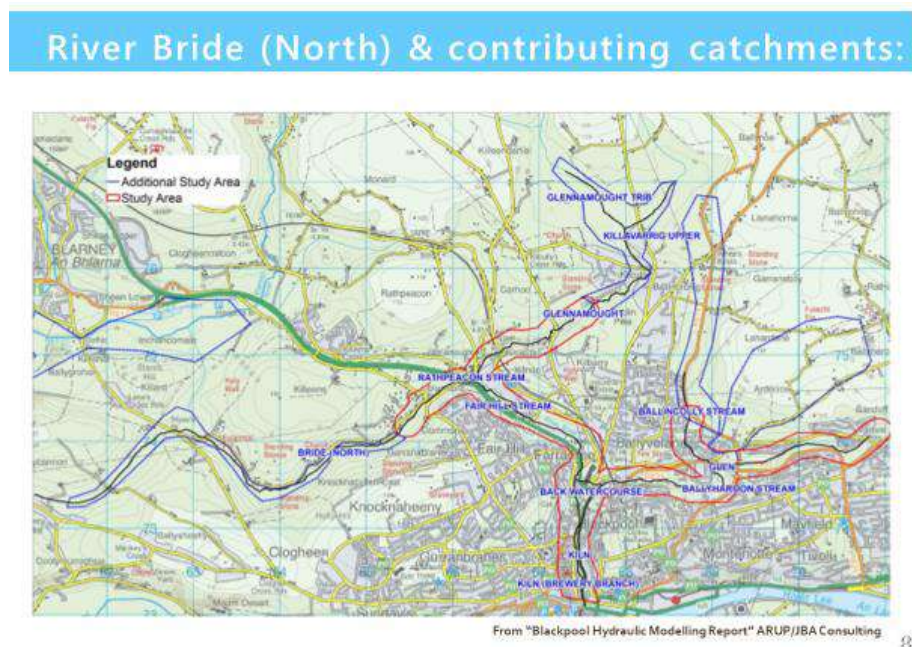
Figure 2.1: River Bride & Catchment Area

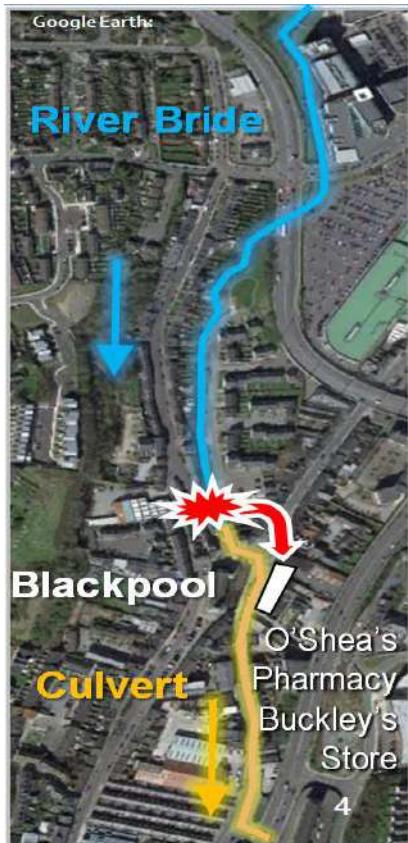
Figure 2.2: Overview of Blackpool Area

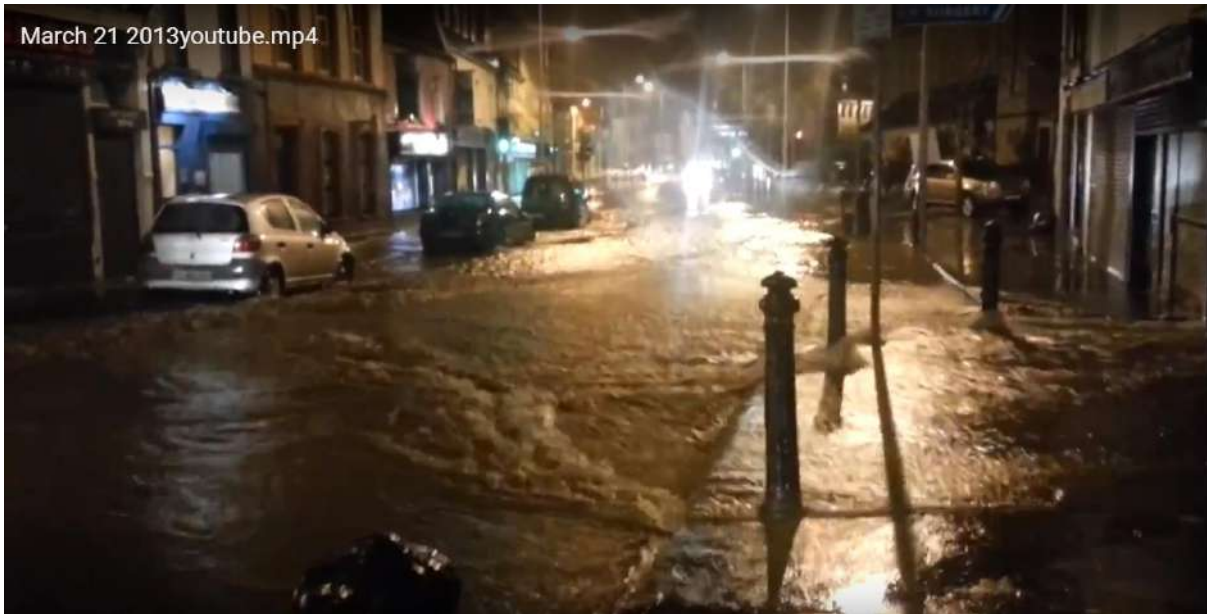
Photo 2.1: Flood water from Orchard Court flowing onto Thomas Davis Street and down into the Village. March 2013

Two factors combine to make flooding in Blackpool risky for residents, the topography of the village, its shaped like a bowl, so when the River Bride overtops its banks at Orchard Court the village fills up in approx. 20 minutes. This is because it's at a lower level than that bank. See still from video of 2013 flooding below. This supporting video can be viewed on the USB stick and the attached PowerPoint slides.

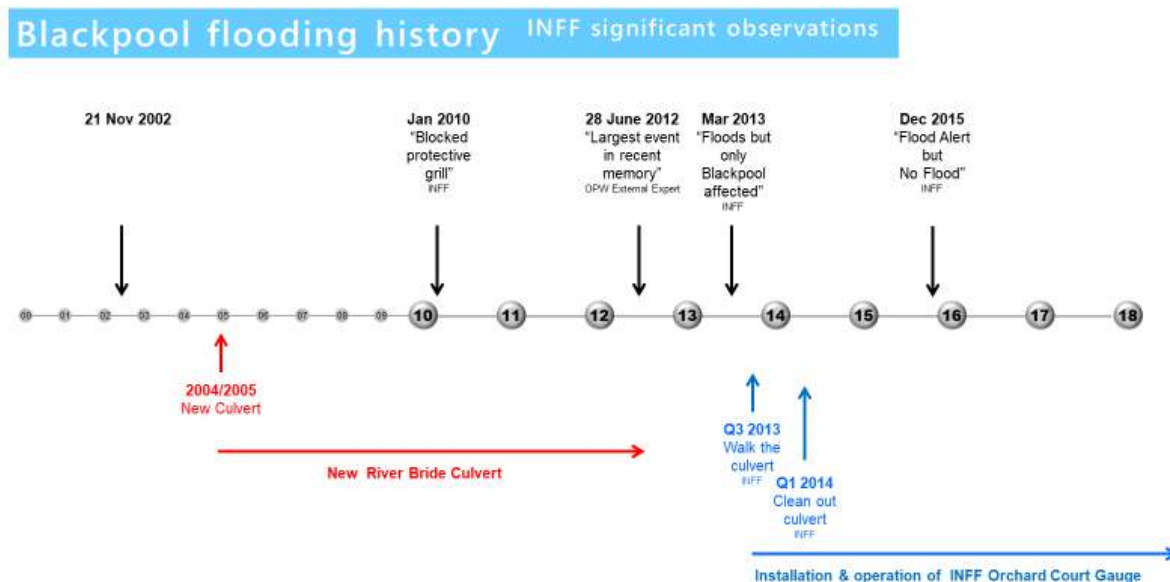
Figure 3.1: Blackpool Flooding History

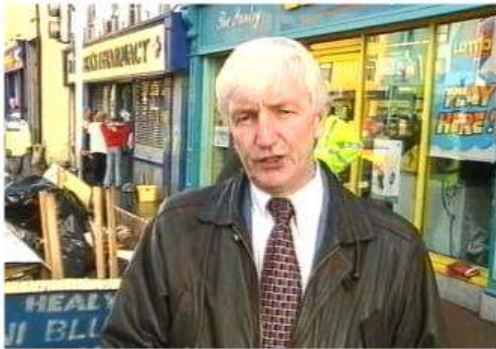
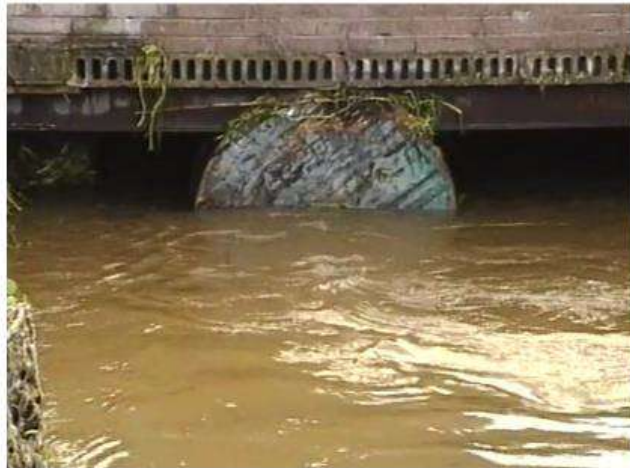
Photos 3.1 (above): Still from video of Barry Mescaill, TG4 reporting from Blackpool Bridge 2002 & Still from the video of a Telecom Eireann reel trapped under culvert entrance in 2002.

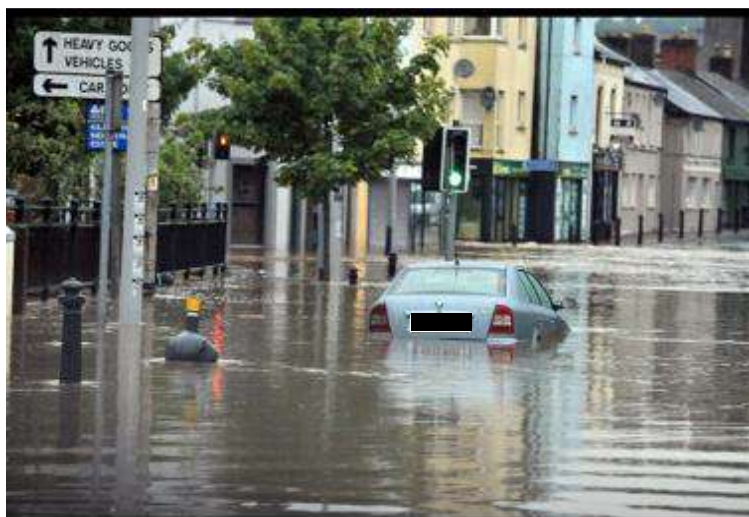
Photo 3.4: Car submerged on Blackpool Bridge in June 2012

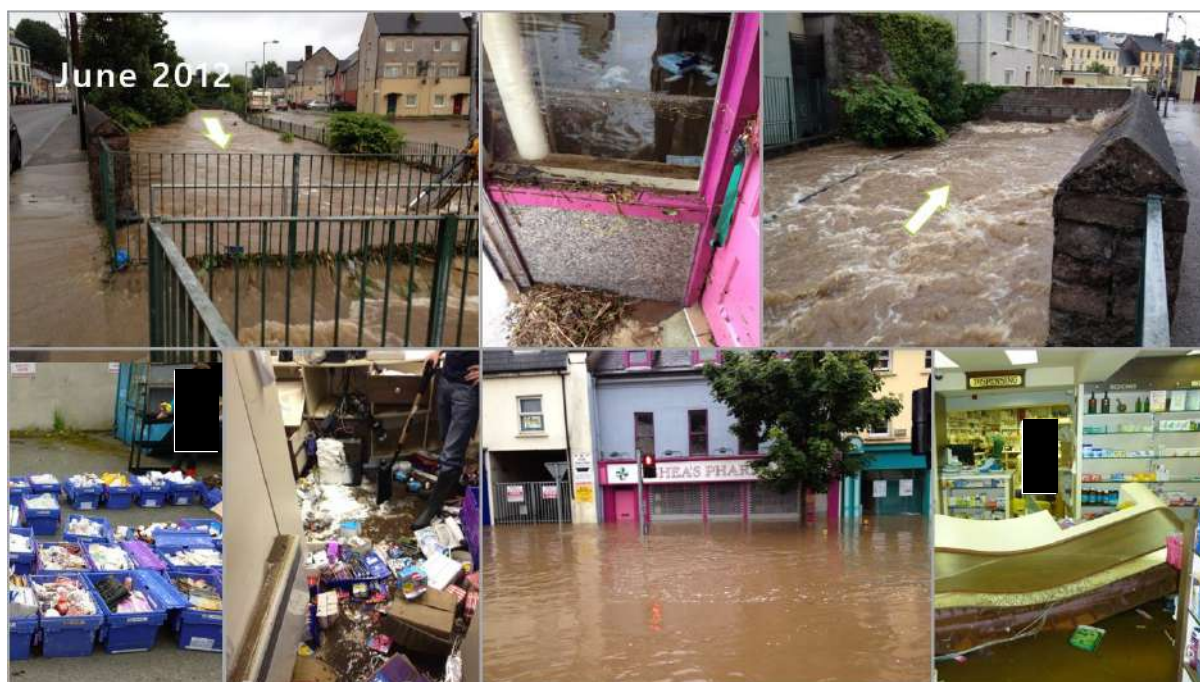
Photo Collage 3.5: Includes photos from O'Shea's Pharmacy perspective; River Bride overtopping the bank on the right-hand side and flooding Blackpool Village 2012; Looking downstream from orchard court pedestrian bridge, flow constrained by underground

rubbish, services in the culvert, and just sheer volume in 2012; A view inside the pharmacy with various equipment and medicines on the floor as the water receded; A view from up on a wall looking across at O'Shea's Pharmacy and Centra 2012; and The force the flood water, upended pharmacy counter looking back into the Pharmacy 2012.

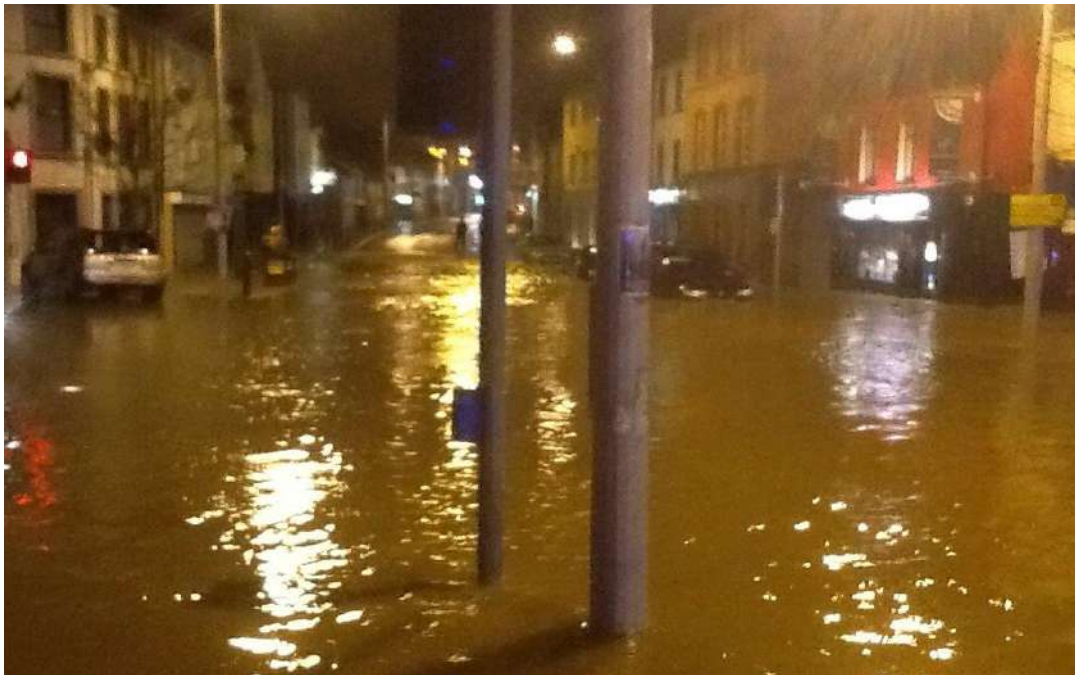
Photos 3.6: View from Blackpool Bridge in March 2013

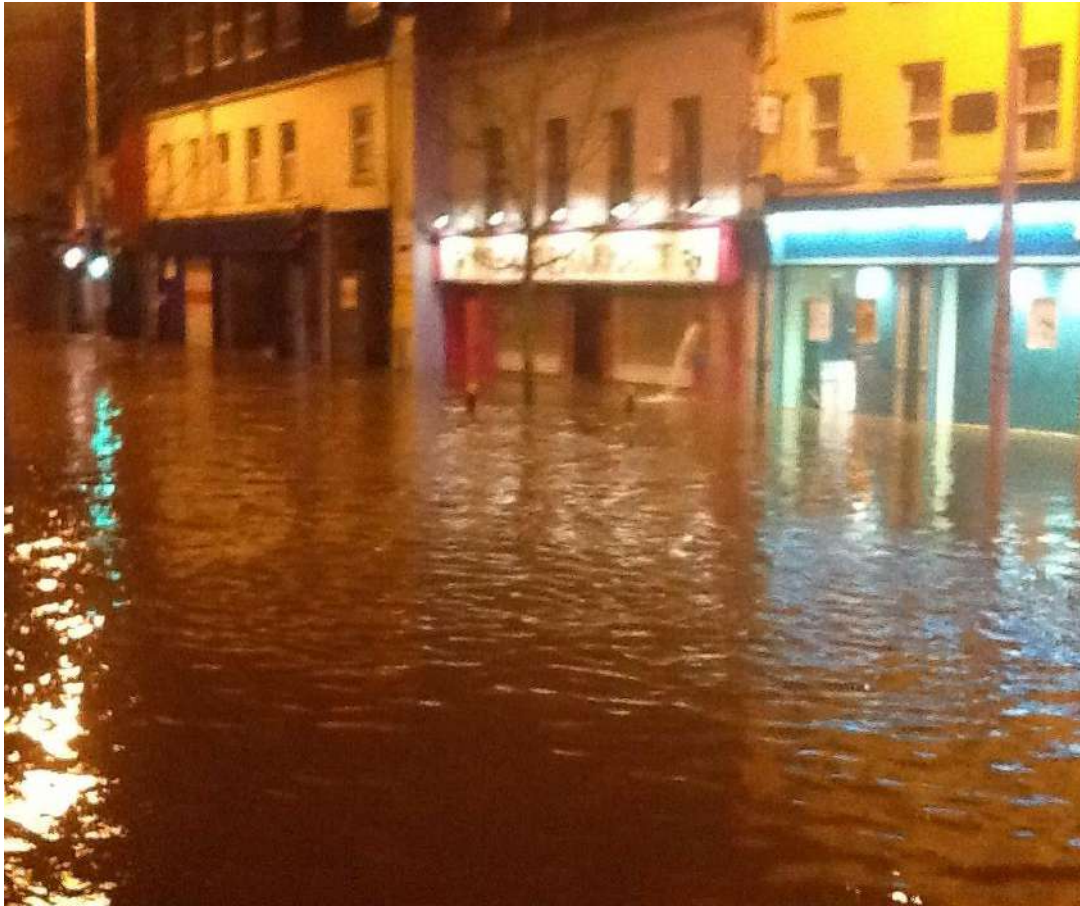
Above. Thomas Davis St Blackpool, March 2013

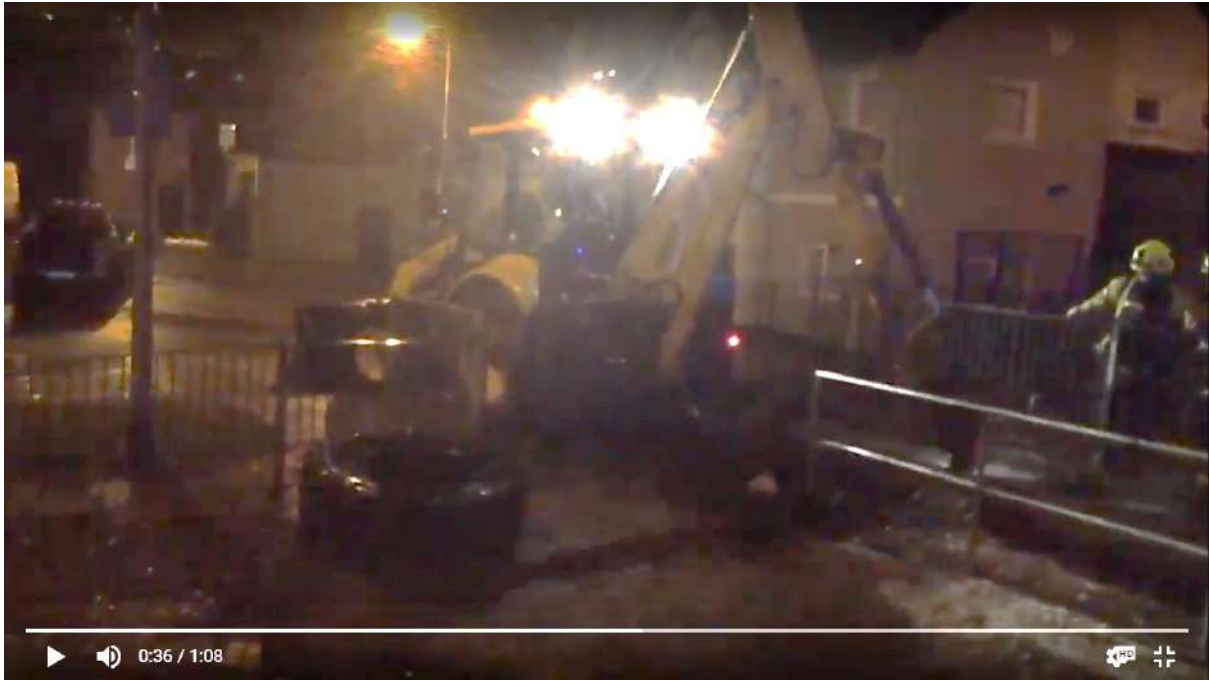
See below: A large tractor tyre came down the river one night during March 2013, trapping other debris in the river to create a matting effect and blinding the screen in the river, leading to the river overtopping the bank on the left hand side at Orchard Court.

Above: Contractor removing rubbish to unblock screen in river, March 2013

The March 2013 floods had only 40mm accumulated rainfall, and the highest hourly total was only 6mm, but a tractor tyre came down the river at night and blocked the trash screen, flooding the village in about 20 minutes. This created a kind of matting effect for other debris, blinding the screen and the river overtopped the banks, flooding the village.

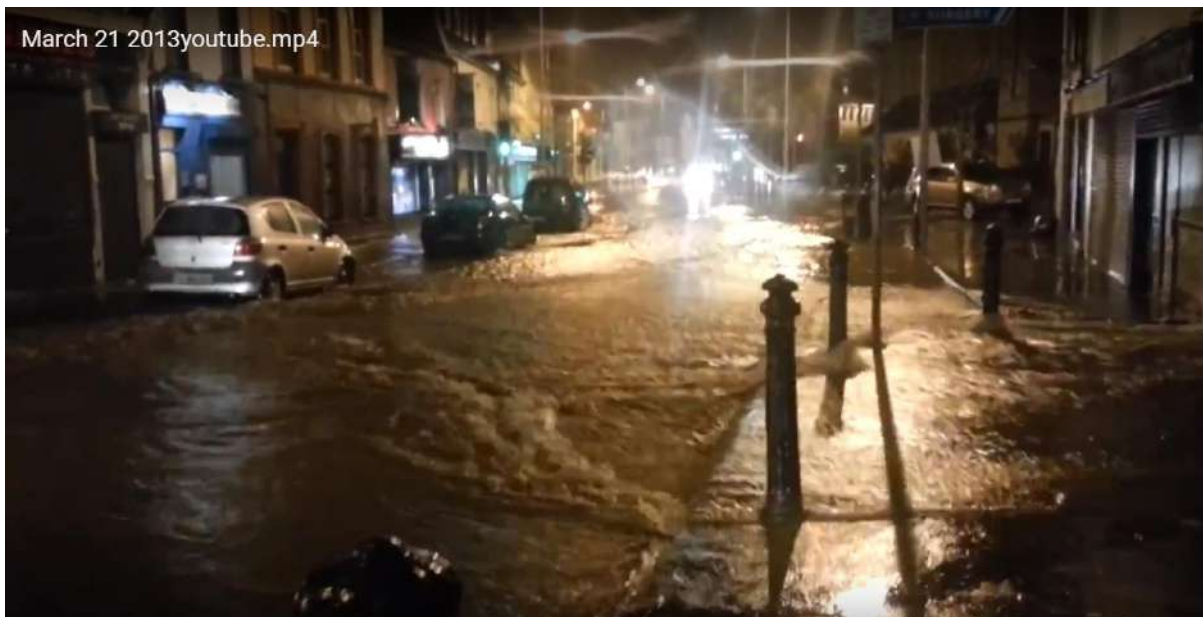
Water flooding out of Orchard Court onto Thomas Davis Street and flooding Blackpool Village

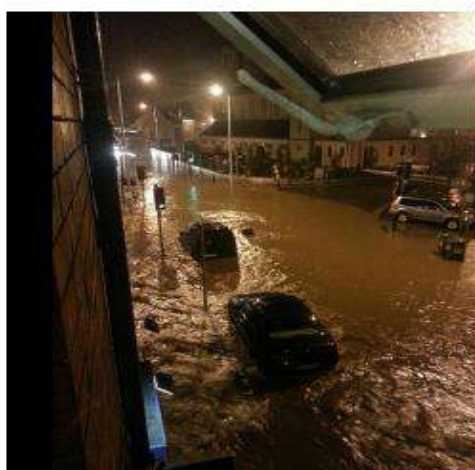
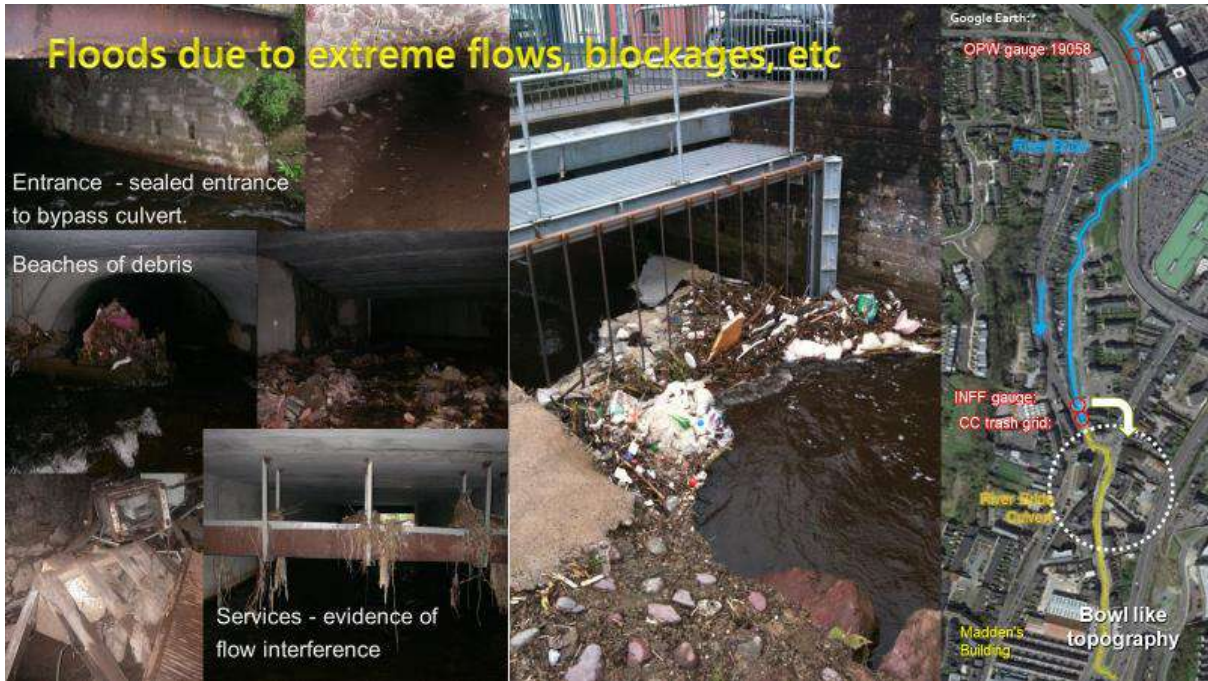
See above Trash screen which was prone to blockage with rubbish

ESB Services Compromising flow in underground culvert.

Blockages and debris compromising capacity in underground culvert downstream of the village

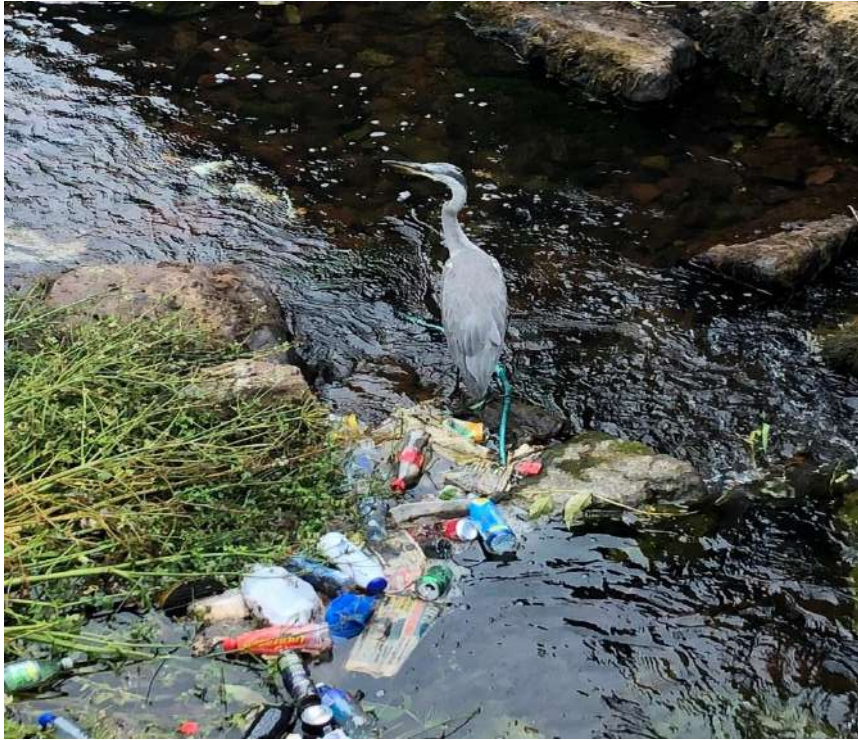
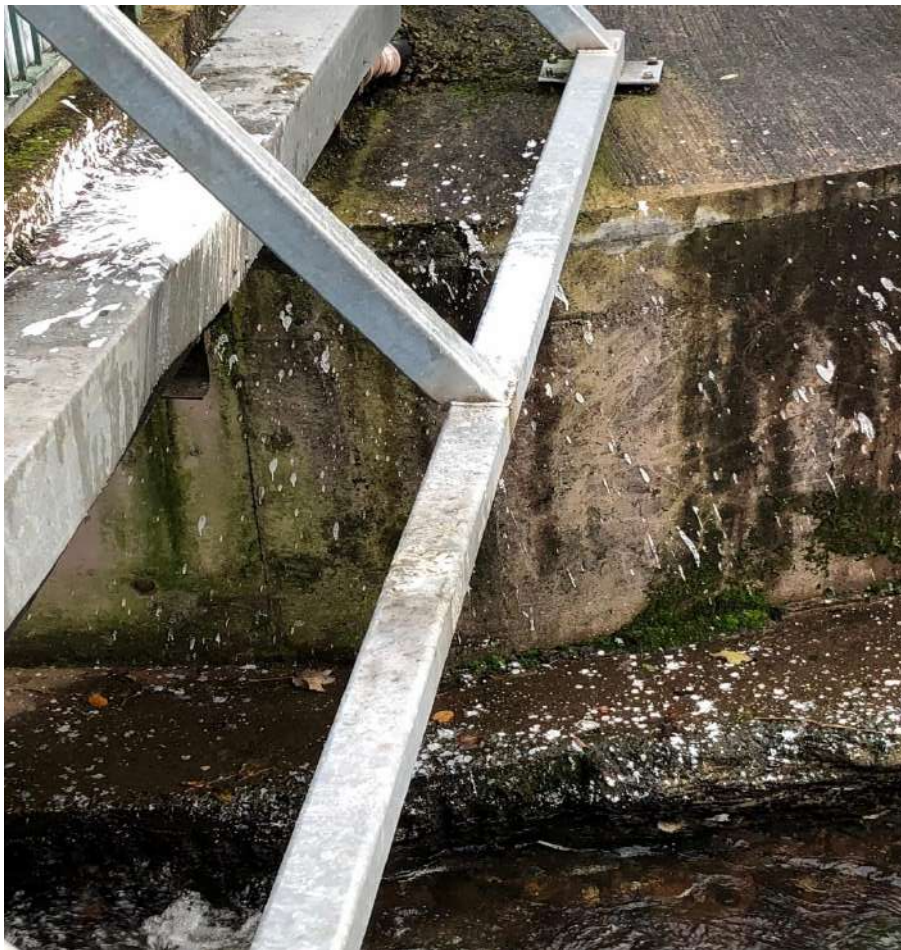
Photos 4.1 & 4.2:

Paint disposed of by being dumped into the River Bride

We argue that the OPW scheme as proposed will help prevent pollution of the River Bride and improve the water quality by keeping dumped material out of the river. As previously mentioned, the Cork City Council cannot remove dumped material easily once it is already in the river. We argue that the current open section of river near Blackpool Bridge is not a good habitat for wildlife due to persistent dumping/fly tipping.

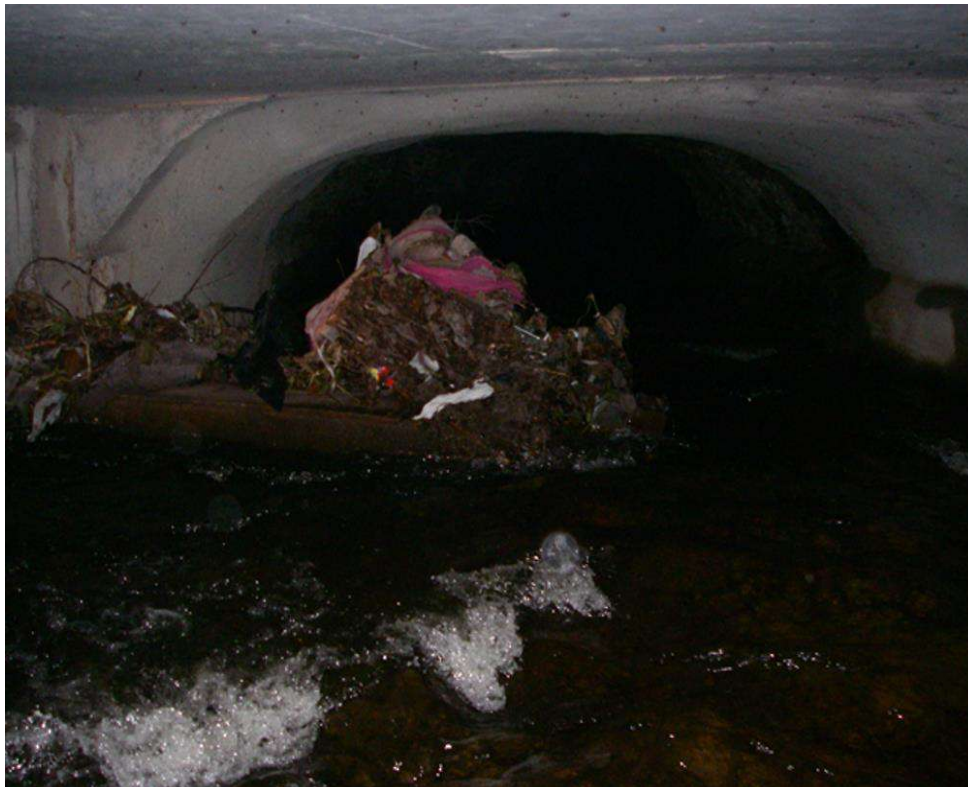
Photo 4.3: Below photo shows Dunnes Stores trolleys and an entangled mattress here coalesce at a concrete lip in the underground culvert, choking the capacity of the “new culvert” from 2004, this is downstream of the village.

We were concerned that the underground sections of the culvert could also be compromised by debris so in November 2013, frustrated by apparent lack of progress locally since 2012, we decided to investigate ourselves. We walked the underground section from Blackpool Church to the Heineken Brewery downstream. We then hosted a meeting for local residents, business owners where we presented photos of the underground culvert system to highlight how compromised the culvert was with rubbish. Capacity was severely compromised in places with items of large debris. Below see some photos taken during this visit to the underground culvert.

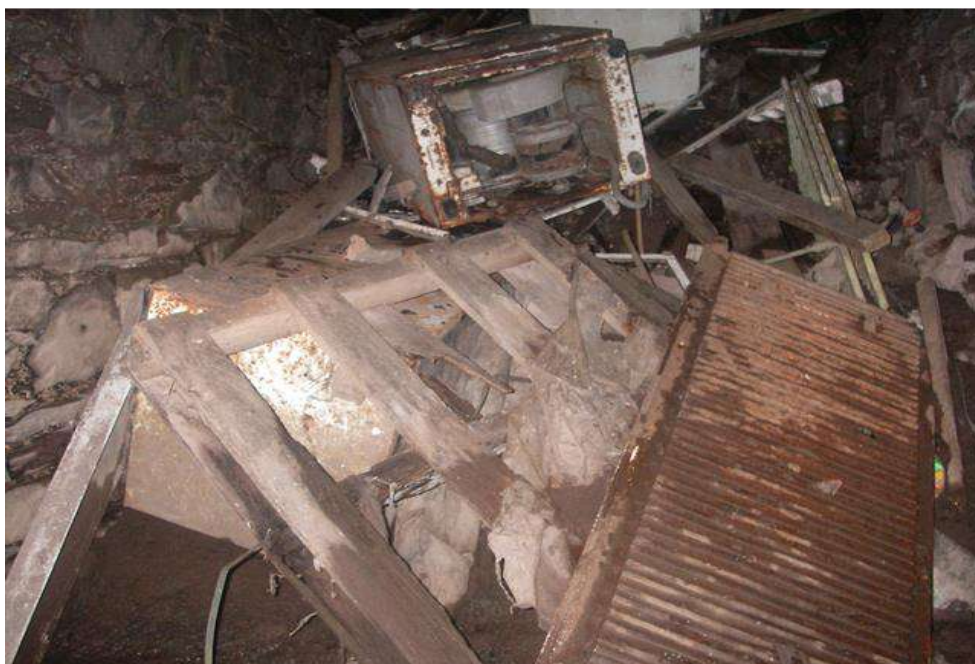
Photo 4.4: Above photo washing machines, radiators and wooden pallets trapped in the underground culvert.

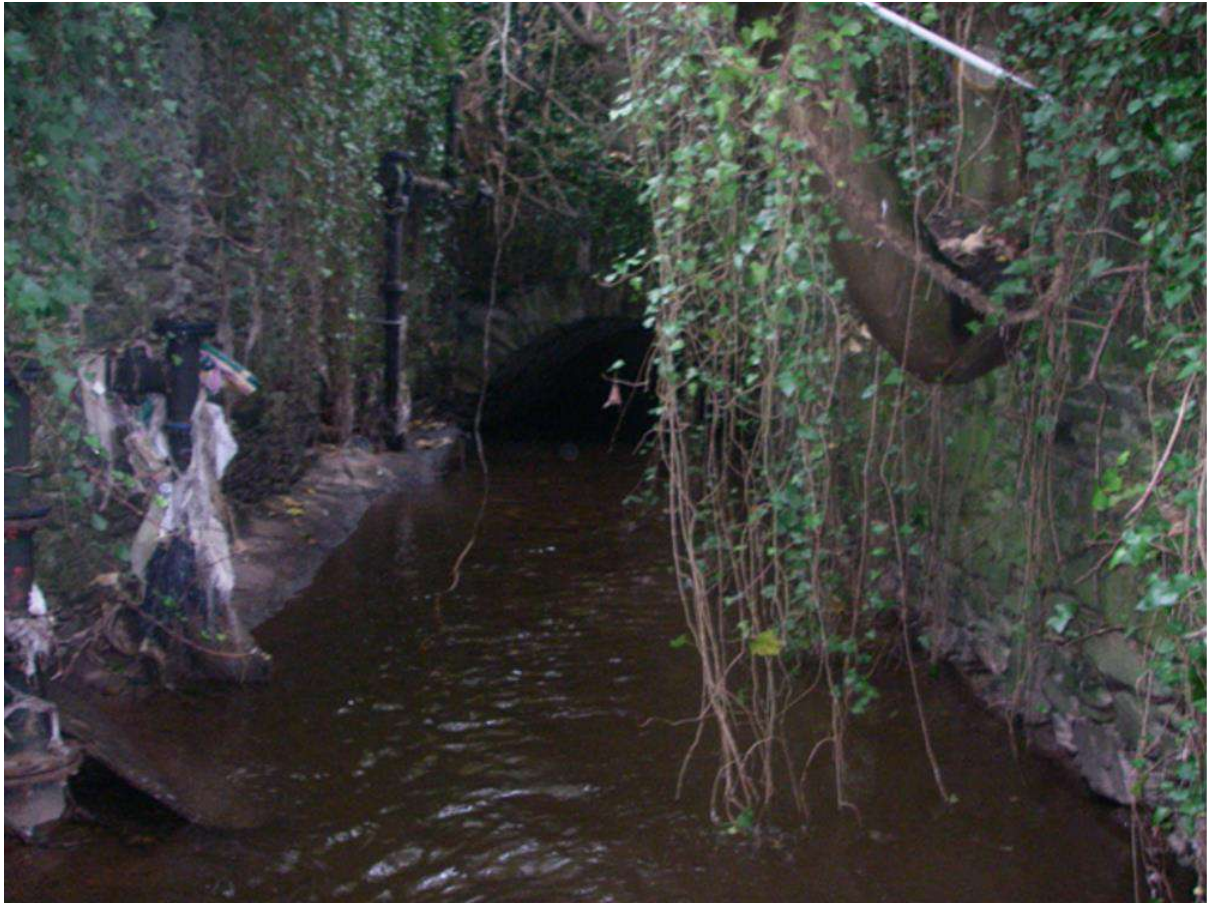
Photo 5.1: Photo showing toilet roll on the vegetation to the left

If you walk the river in Orchard Court on warm day there is a strong smell of sewage, so we feel that there is at least some raw sewage being discharged into the river here. If you examine the photos of the close to the culvert, you will notice in Photo 5.1 below a large amount of toilet paper trapped on plant vegetation. This was taken down beside the Heineken Brewery.

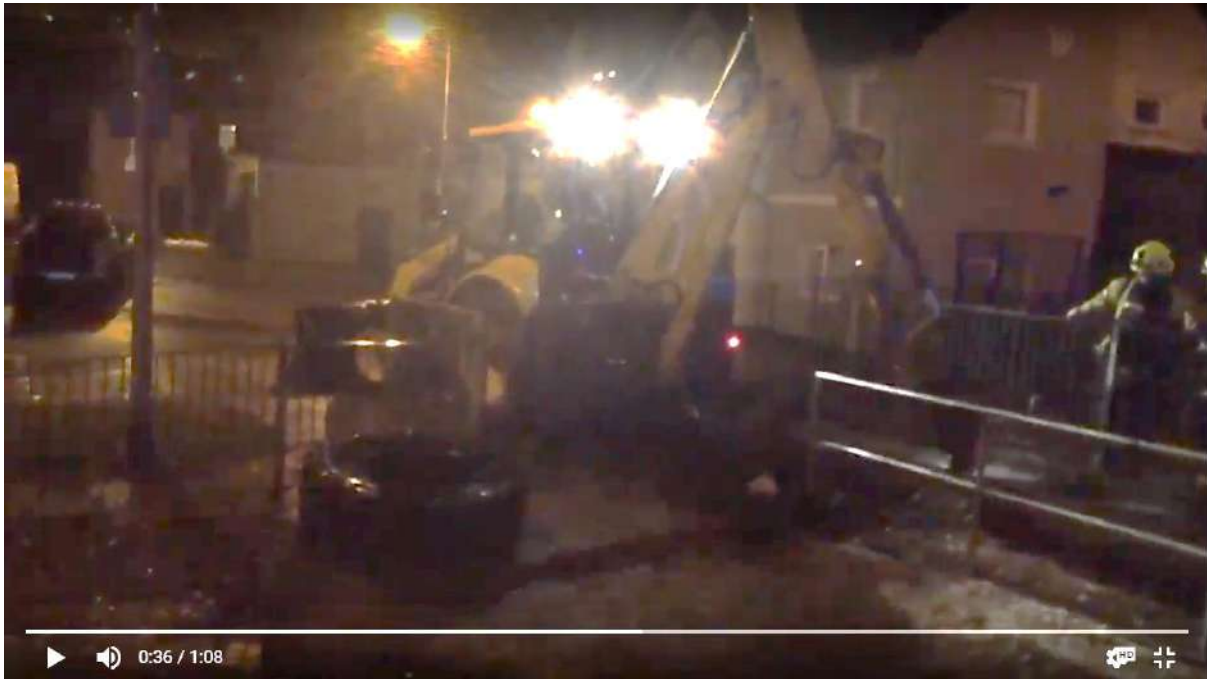
Photo 6.1: JCB removing a large tractor tyre trapped at the pedestrian bridge in Orchard Court in March 2013.

The contractor hired by Cork City Council to remove debris if the screen in Blackpool was located on the other side of the city. This became a problem when the screen was blocked with rubbish as the contractor had to first cross the city. As discussed in Section 3, the village floods quickly.

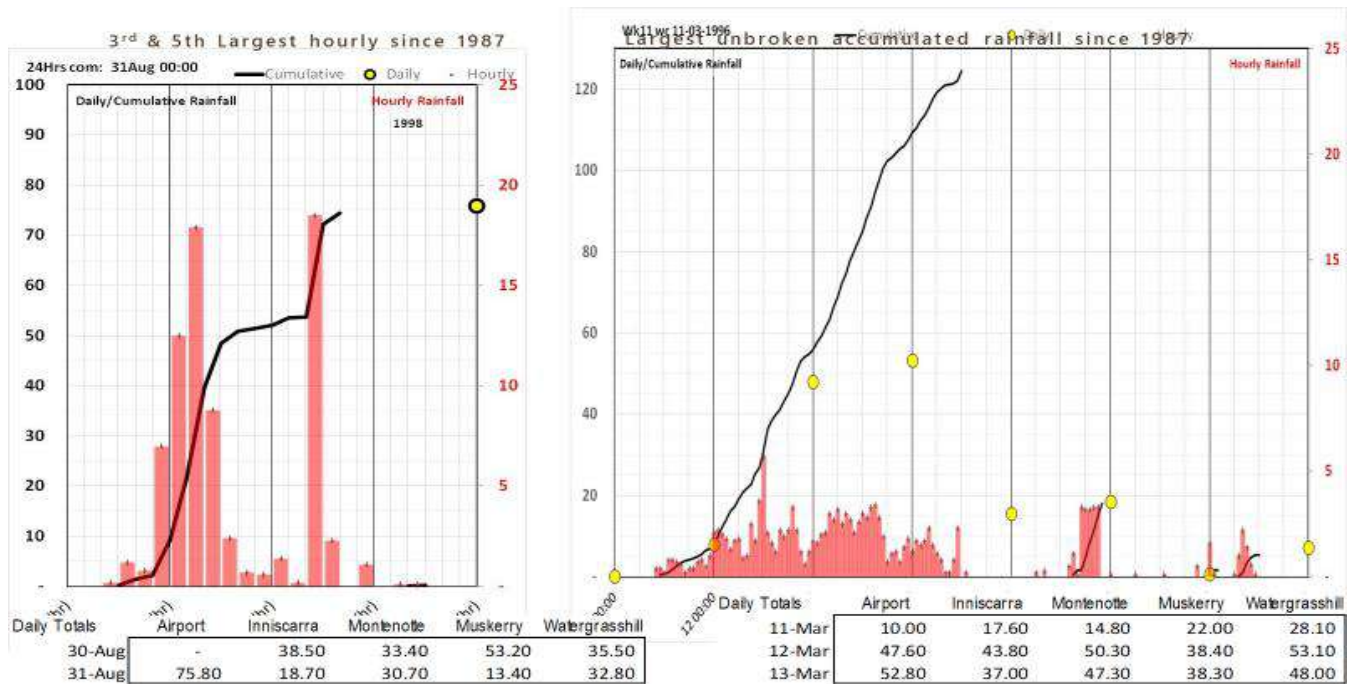
Chart 6.1: The above chart is a comparison of largest cumulative 24 hr rainfall (where break in rainfall is not more than 1hr) and largest hourly rainfall totals for Cork Airport 1987 to 2017.

Cork Airport which is approx. 8 km from Blackpool, as the crow flies. Above shows data from recent floods. When the data from 2012 and 2013 is considered, you will notice that flooding occurred in 2013 from modest rainfall. Considering climate change, higher levels of, and more intense, rainfall can be expected. Changes in the climate and the increased risk of extreme rainfall again underlines the need for the scheme to proceed without any further delay.

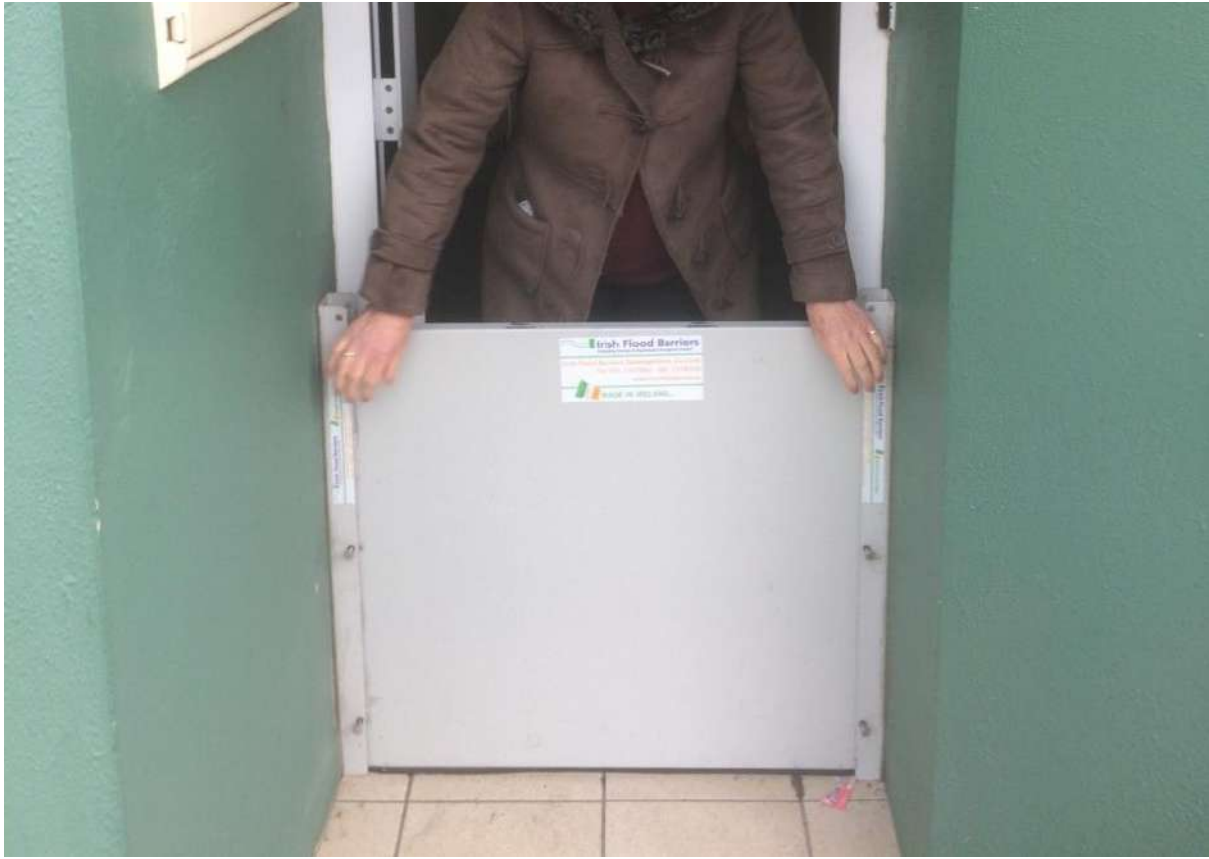
The photo below shows a protective flood barrier, distributed to residents after another flood in 2012. Note these cast-iron flood barriers are heavy and some residents must call on family and neighbours for help. They are then effectively trapped inside if they can't lift these barriers themselves, which causes stress if there was a fire or a need to evacuate the house quickly.

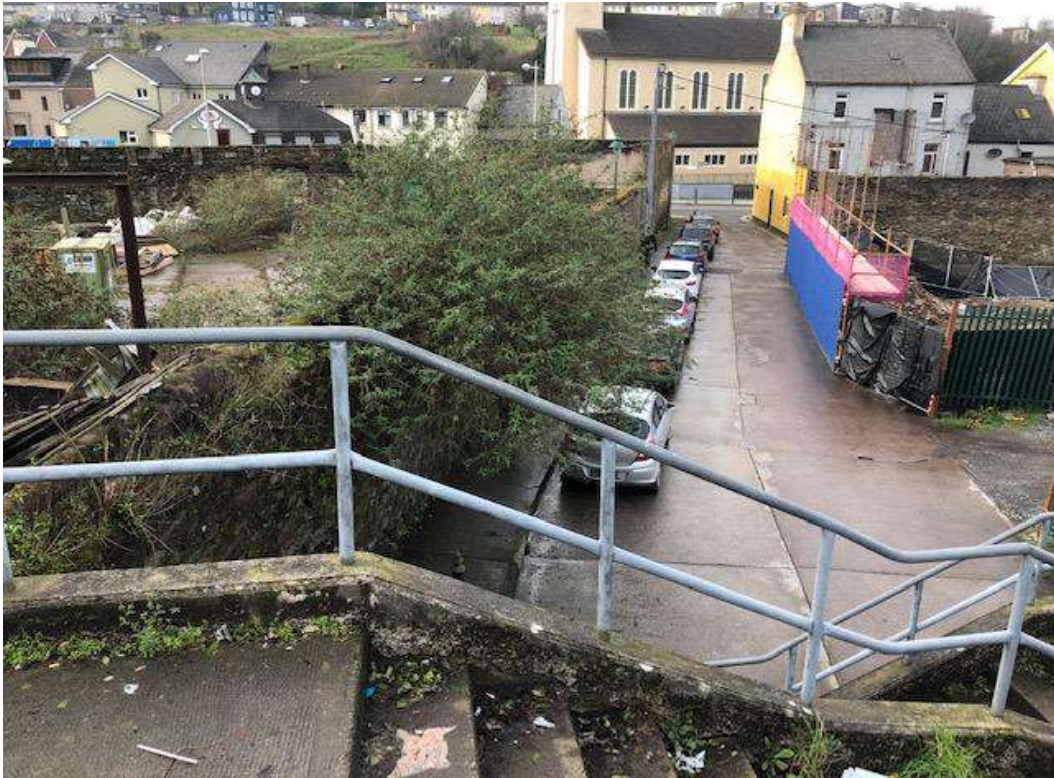
Photo 9.1: This photo taken from the Blackpool By-pass at Corcoran's quay looking west towards the church, 18/02/2020. See apartments under construction on the right-hand side at Corcoran's Quay., under the Blue tarp. Approx. 9 apartments here. Also see old OS forklift site on the left hand side of the parked cars with planning for 37 apartments, (planning notice below in Photo 9.3)

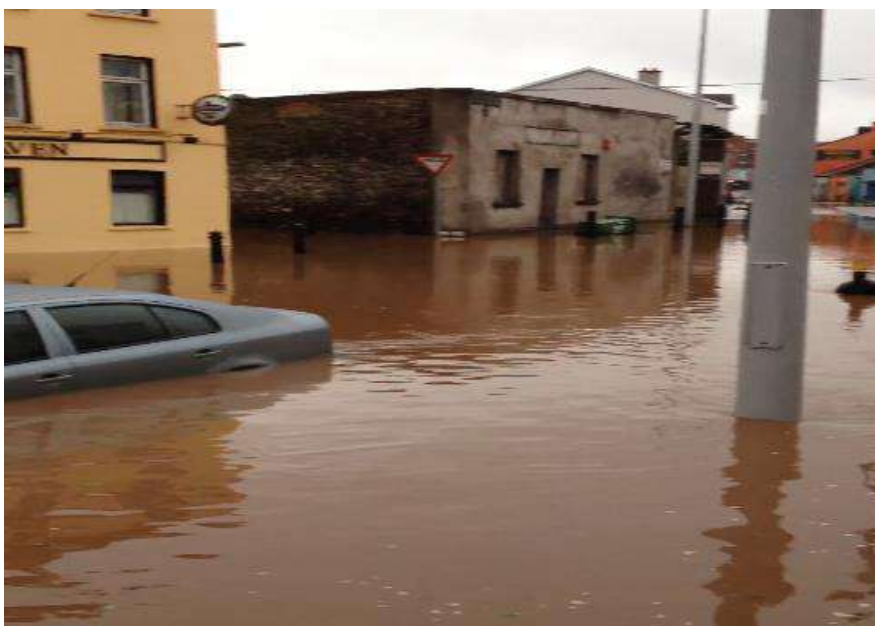
OS forklift site, to right of Berehaven Bar, from 2012. Still from video footage on my phone. Full footage attached. New developments will also need to be protected

If one is to look at the photos from the 2012 event, these sites can be seen flooded to a considerable depth. Consult flood mapping of extent of 2012 event if necessary. This illustrates that the apartments listed above will have the potential to be flooded to a considerable depth, see photo below from 2012. Yet these apartments and extra housing are badly needed in Cork, as is the case across the country.

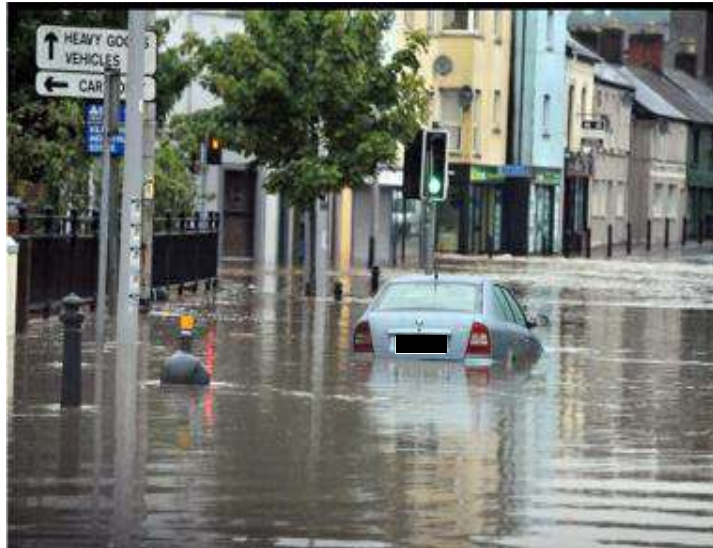
Photo 9.4: This Photo is taken from Thomas Davis street in 2012, looking north. The church is on your left hand side, and you are standing roughly in front of the OS forklift site, with both these apartment sites to your direct left.
