Prepared for
The Moore Street Consultative Group
by
Paul Arnold Architects
November 2016

MOORE STREET SELECTED EXTERNAL PHOTOGRAPHS

MOORE STREET SELECTED INTERNAL PHOTOGRAPHS

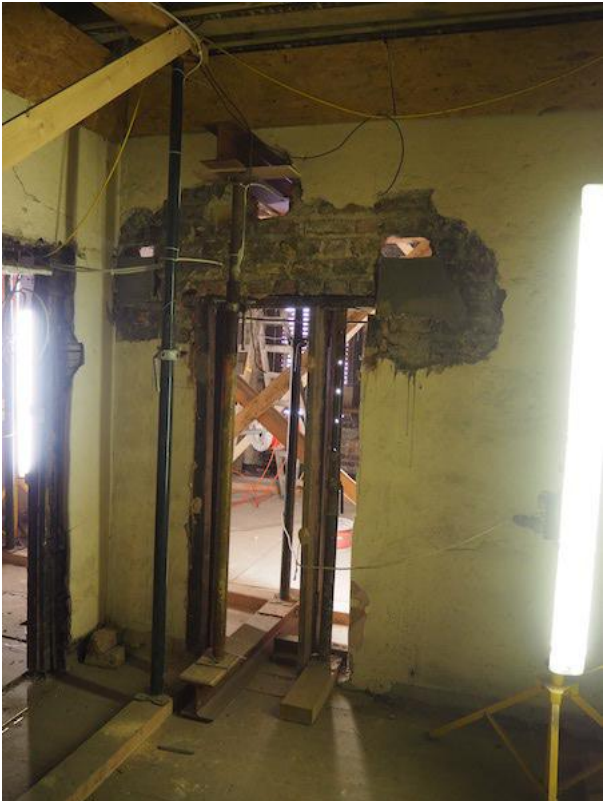
P15.3 One of the new openings to allow circulation between buildings

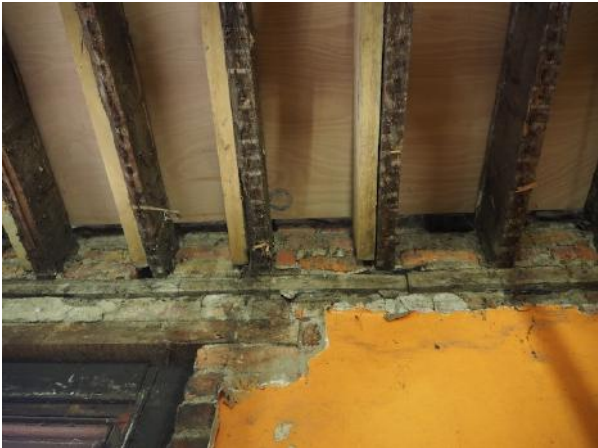
P15.5 The masonry surround joist ends is precarious

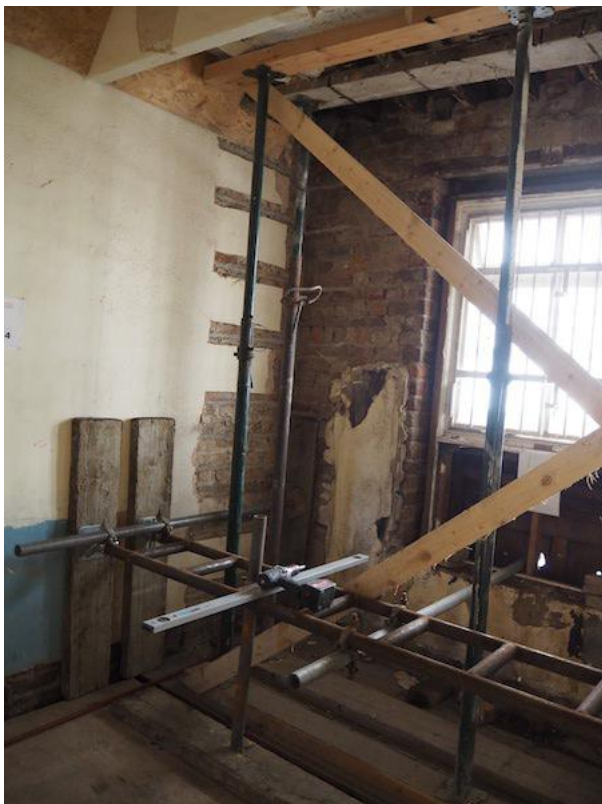
P28.3 Some of the propping and restraint systems are quite elaborate
