Marine Notice No. 51 of 2022

Checking hydrostatic release and remote activation function of Emergency Position Indicating Radio Beacons (EPIRB's)

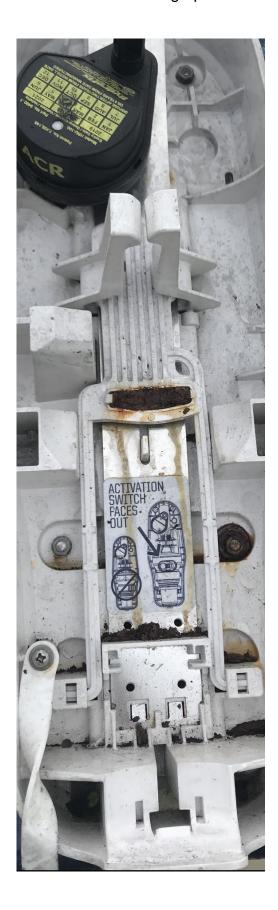
It has come to the attention of the Irish Maritime Administration that the associated bracket for the hydrostatic release and remote activation function of some EPIRB's have been found with defective magnets suffering degradation, after less than 2 years from installation.

A photograph of a degraded magnet is provided in Appendix 1. (see below)

APPENDIX 1 – Photograph of Deterioration of Activating Magnet

All owners or persons responsible are requested to inspect this equipment onboard or to request their shore-based maintenance provider to do so, to confirm that the EPIRB's float free and automatic release mechanism is functioning correctly. Special attention should be paid to the inspection of magnets and to drain holes in float free housings, especially in horizontally mounted units.

Any defective equipment should be reported to:

- the radio surveyor who carried out the last safety radio survey or the Marine Survey Office and
- the supplier and installer of the equipment or the shore-based maintainer of radio equipment for the vessel.
