Prepared for
The Moore Street Consultative Group
by
Paul Arnold Architects
November 2016

MOORE STREET SELECTED EXTERNAL PHOTOGRAPHS

MOORE STREET SELECTED INTERNAL PHOTOGRAPHS

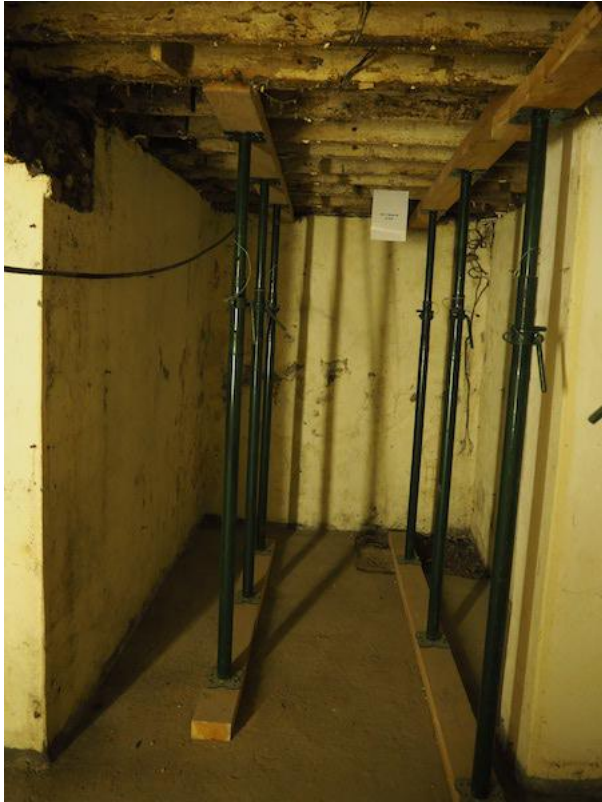
P37.1

P36.6 Portion of a basement wall exposed to reveal the alluvial and esker stones of which it is made.

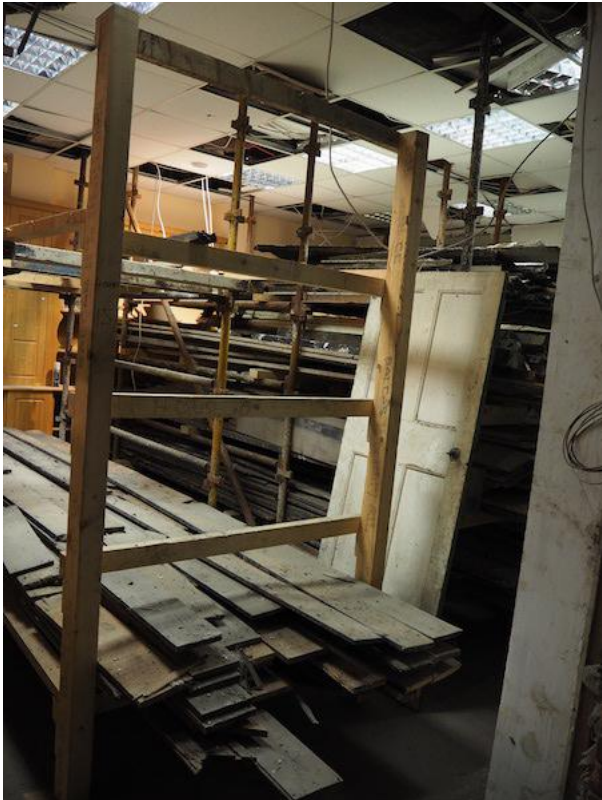
P42.1 Removed material is stored in racks, organised by building and by floor
